Corrosion Test TEST REPORT

Of ISO 9227:2017 Applied for SASO-2927

Beschreibung des Produkts: <i>Product Description:</i>	LED STREET LIGHT
Modelle: <i>Models:</i>	AOK-200WiL02-NV-L3-00-40
Bewertung: <i>Rating:</i>	AC120-277V, 50/60Hz, 200W, 2200mA
Verfahren: <i>Method:</i>	SASO 2927: 2019:Energy efficiency functionality and labelling requirements for lighting products – Part 3: Street lighting ISO 9227:2017: Corrosion tests in artificial atmospheres—Salt spray tests
Prüfergebnis*: <i>Test result*:</i>	The Rating 8 classification after corrosion test 2,500h

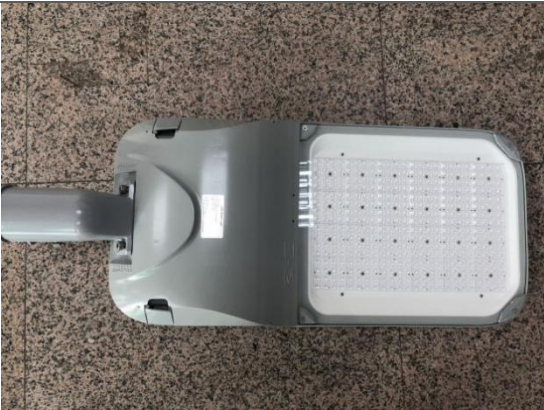
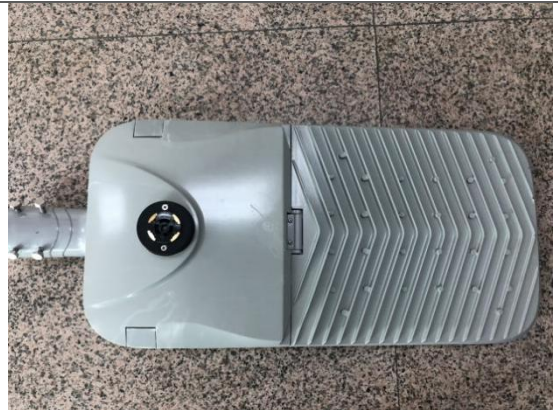
Sample Photo after the Test:

7. Test Results: After tested, the sample appearance had not obvious corrosion and function was normal

Sample No.	The classification after 2,500	Verdict
1	8	After the test, only a little corrosion on the sample surface.
Remark: AOK-200WiL02-NV-L3-00-40 model
