Report No.:SZA EK190703010-01

Test Report

Product Name : LED Street Light

Shenzhen Anbotek Compliance Laboratory Limited

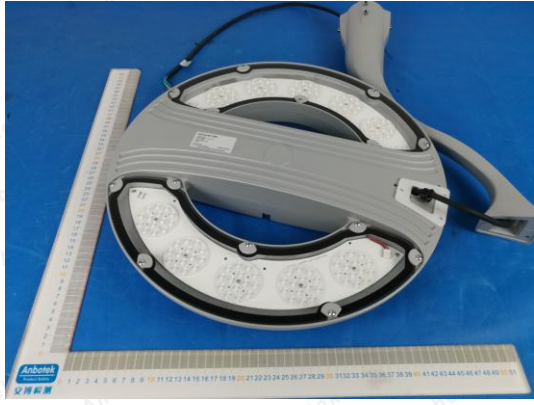
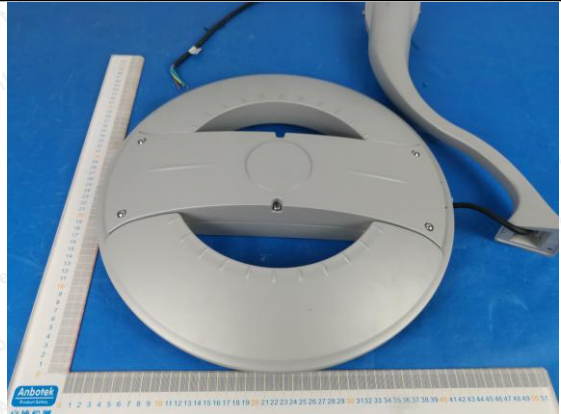
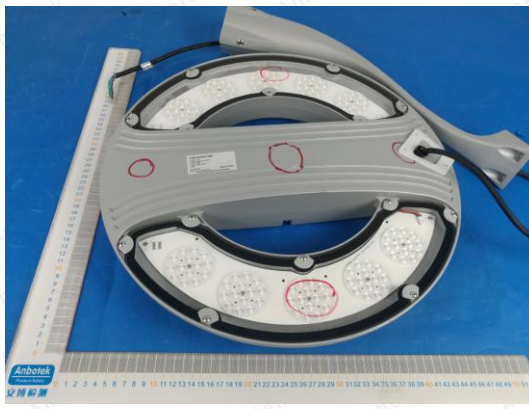
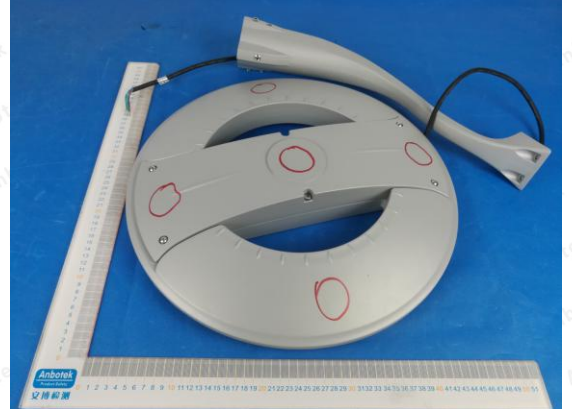
Before Test		Before Test

Before Test

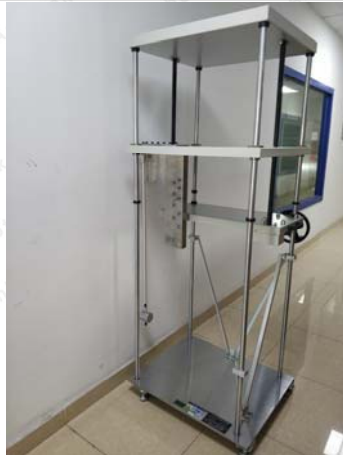
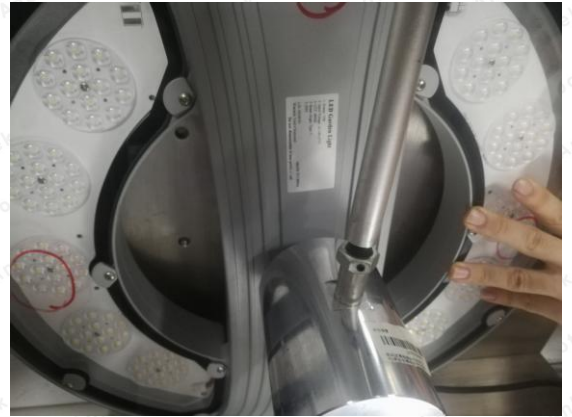
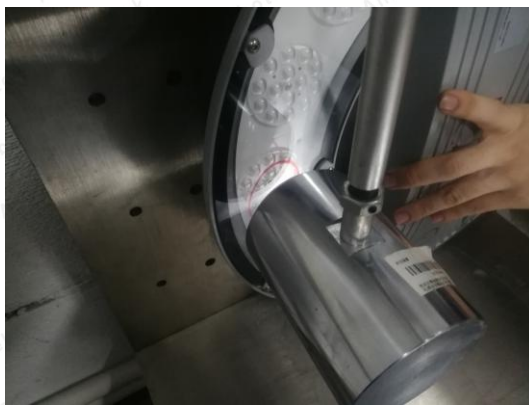
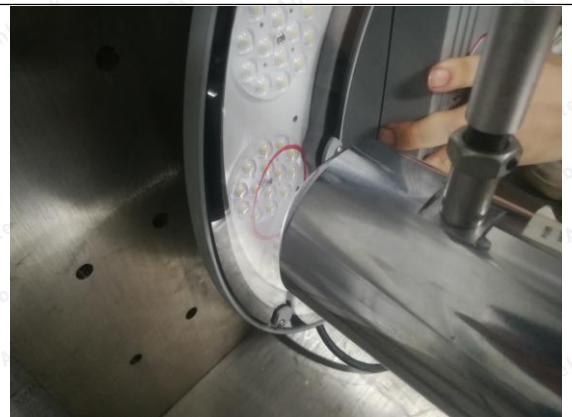
Test set-up

1. IK09				
Test Standard	IEC 62262-2002			
Test Condition	<p>The test remark and the matters needing attention:</p> <p>--- the sample is Installed on the rigid support surface, Begin the impact test from a height of 200 mm using the pendulum 5 kg, The energy of impact test specimens for 10J;</p> <p>--- The impact of 5 points evenly distributed in the each exposed surface of the sample;</p> <p>--- There shall be no more than three collisions applied near the same position of the enclosure;</p> <p>--- Check the sample after the test.</p>			
Test Equipment	Equipment Name	Equipment No.	Equipment model	Equipment Cal validity period
	IK impact tester	SE-1459	GRPH-2	2019.12.19
Test Result	Sample No.	Test requirements	Test Result	Evaluation
	SZAEK190703010-S1	The sample housing is allowed to be slightly cracked, dented and not to be seriously damaged.	The sample housing is normal after test.The sample housing is not cracked,dented and damaged.	PASS

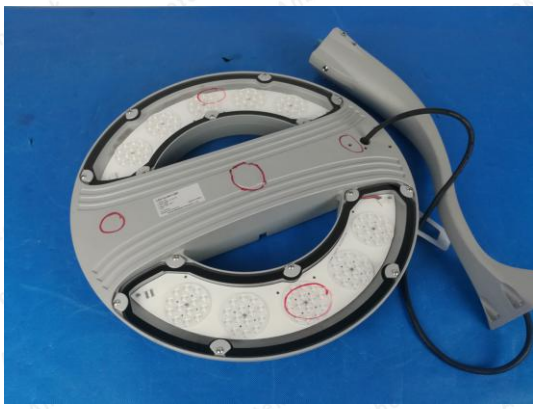
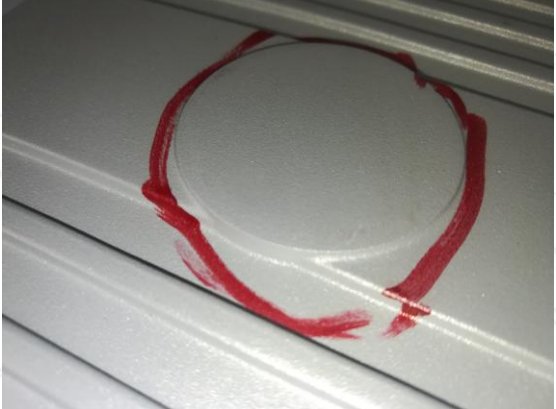
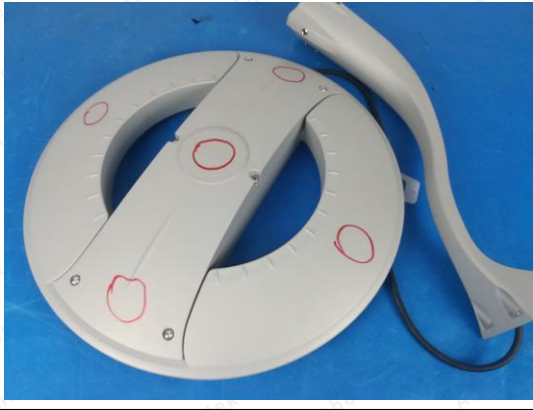
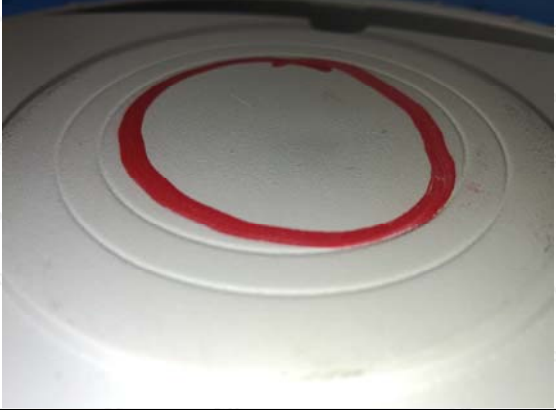
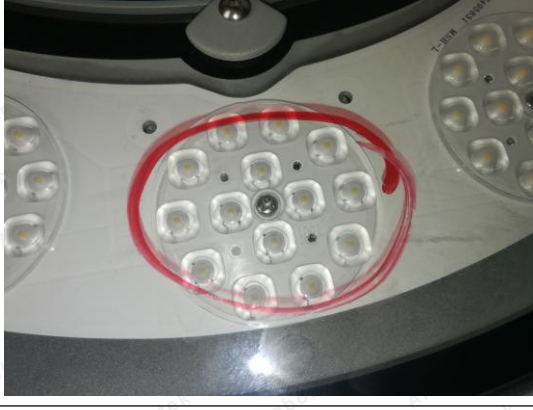
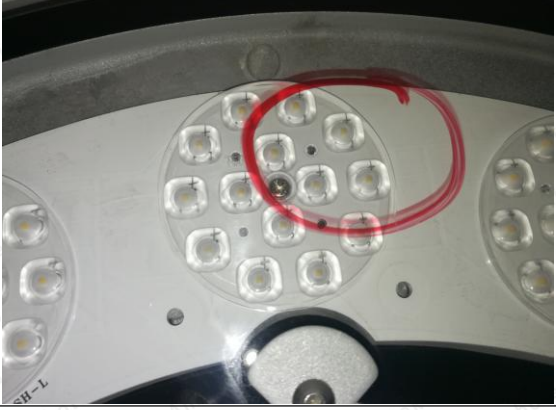
After Test	After Test
